**Flood Control Project Maintenance
Levee Inspections**
LMA District Cover Sheet
Spring 2019 Levee Inspection Results

American River Flood Control District

Spring 2019 Levee Inspection Results

Waterway			Bank	Unit Miles
Unit No. 01 Arcade Creek			Left	2.08
	Spring (March - May)	Summer (June - August)	(September - November) Fall	Winter (December - February)
Unit Maintenance Rating (Fall Only)				
Date of Inspection	5/14/2019 - 5/14/2019			
DWR Inspector	Luz Dial			
Accompanied By	Ross Kawamura ARFCD

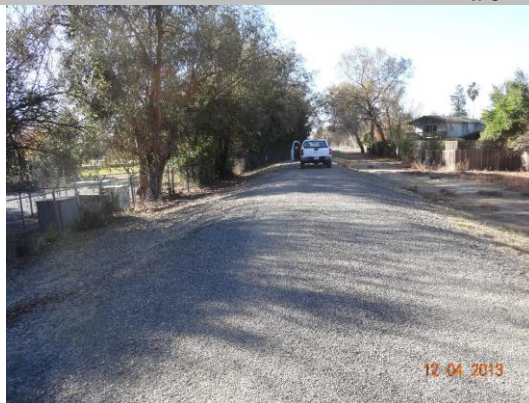
Photo 1 of 3 : UCIP_SP_2019_41536_47550.jpg

LM Start	1.28	Rating **	M	Issue No.	56
LM End	1.28	Issue Type +	En	Location *	
Category	Supplemental			GPS Latitude/Longitude	
				Start	End
Item	DWR UCIP Field Study			38.583873 °	38.583873 °
				-121.340037 °	-121.340037 °
DWR ID	24097				
Comment Code					
Inspector Comment					
FS_ID:41536 DS_ID:24097 EP_NO: 12276 Repair Type: Non-Urgent Crossing Status: Indicator Found UCIP Comments: Unable to find markers indicating crossing through levee. FIELD_STRUCT_DESC: Two 3-inch polyvinyl chloride (PVC) electrical conduits through the levee, 3 feet below the crown. Northeast Sewage Treatment Plant on waterside (WS). Conduits extend from treatment plant to transformers located on WS. (two 3-inch conduits authorized under Permit No. 12276-1980) [Additional Reference(s): DWR Levee Log, 2002] FS Date: 12/4/2013

Overview of levee looking downstream.

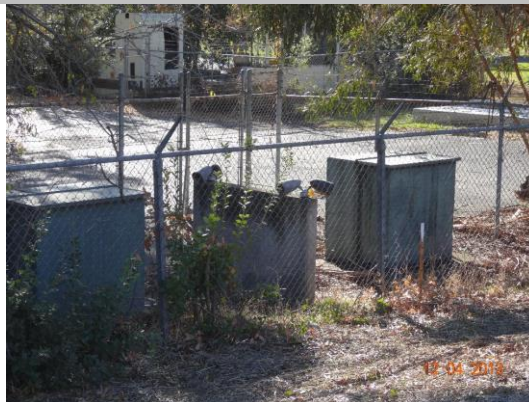
Photo 2 of 3 : UCIP_SP_2019_41536_47549.jpg

View of transformers located on waterward side.

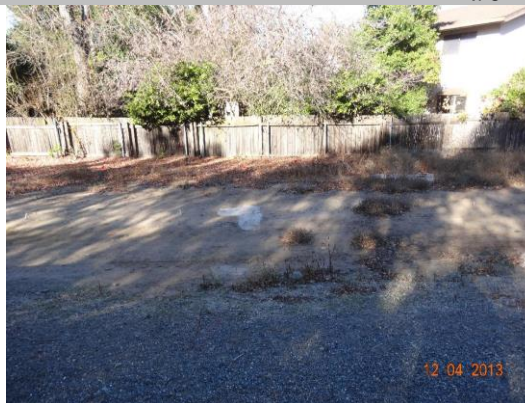
Photo 3 of 3 : UCIP_SP_2019_41536_47551.jpg

LM Start	1.28	Rating **	M	Issue No.	56 (cont)	
LM End	1.28	Issue Type +	En	Location *		
Category	Supplemental			GPS Latitude/Longitude		
				Start		End
Item	DWR UCIP Field Study			38.583873 °		38.583873 °
				-121.340037 °		-121.340037 °
DWR ID	24097					
Comment Code						
Inspector Comment						
FS_ID:41536 DS_ID:24097 EP_NO: 12276 Repair Type: Non-Urgent Crossing Status: Indicator Found UCIP Comments: Unable to find markers indicating crossing through levee. FIELD_STRUCT_DESC: Two 3-inch polyvinyl chloride (PVC) electrical conduits through the levee, 3 feet below the crown. Northeast Sewage Treatment Plant on waterside (WS). Conduits extend from treatment plant to transformers located on WS. (two 3-inch conduits authorized under Permit No. 12276-1980) [Additional Reference(s): DWR Levee Log, 2002] FS Date: 12/4/2013

View of landward side.

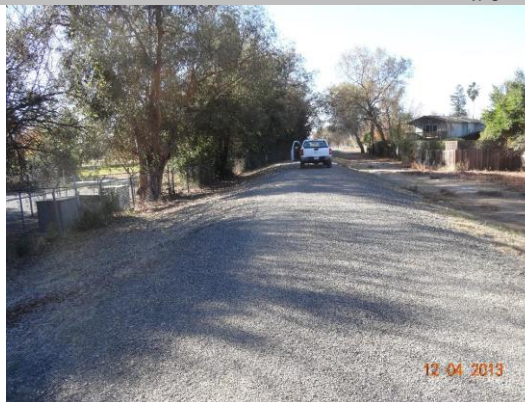
Photo 1 of 3 : UCIP_SP_2019_26299_47575.jpg

LM Start	1.28	Rating **	M	Issue No.	57
LM End	1.28	Issue Type +	En	Location *	
Category	Supplemental			GPS Latitude/Longitude	
				Start	End
Item	DWR UCIP Field Study			38.583873 °	38.583873 °
				-121.340037 °	-121.340037 °
DWR ID	24477				
Comment Code					
Inspector Comment					
FS_ID:26299					
DS_ID:24477					
EP_NO: 7993					
Repair Type: Non-Urgent					
Crossing Status: Found					
UCIP Comments: 12/04/2013 Unable to confirm if crossing buried is the same as this crossing. (DWR UCIP - O. Magana)					
FIELD_STRUCT_DESC: 6-inch plastic lined steel pipe through the levee at unknown depth. Steel cutoff wall around pipe at center of levee. (6-inch line authorized under Permit No. 7993, 7993-A, 1973 - Northeast Sacramento County c/o Sanitation District Department of Public Works Water Quality Division)					
FS Date: 12/4/2013

Overview of levee crown looking downstream.

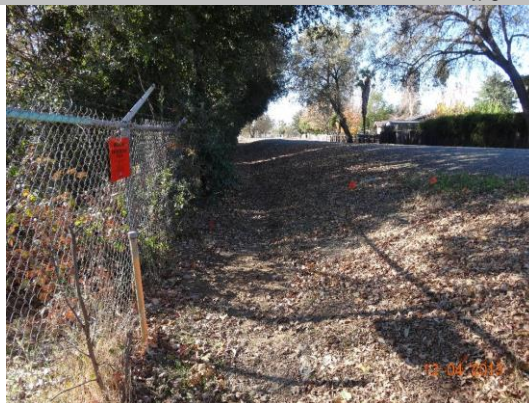
Photo 2 of 3 : UCIP_SP_2019_26299_47574.jpg

LM Start	1.28	Rating **	M	Issue No.	57 (cont)	
LM End	1.28	Issue Type +	En	Location *		
Category	Supplemental			GPS Latitude/Longitude		
				Start	End	
Item	DWR UCIP Field Study			38.583873 °	38.583873 °	
				-121.340037 °	-121.340037 °	
DWR ID	24477					
Comment Code						
Inspector Comment						
FS_ID:26299 DS_ID:24477 EP_NO: 7993 Repair Type: Non-Urgent Crossing Status: Found UCIP Comments: 12/04/2013 Unable to confirm if crossing buried is the same as this crossing. (DWR UCIP - O. Magana) FIELD_STRUCT_DESC: 6-inch plastic lined steel pipe through the levee at unknown depth. Steel cutoff wall around pipe at center of levee. (6-inch line authorized under Permit No. 7993, 7993-A, 1973 - Northeast Sacramento County c/o Sanitation District Department of Public Works Water Quality Division) FS Date: 12/4/2013

View of waterward side--Underground Alert System markers showing alignment.

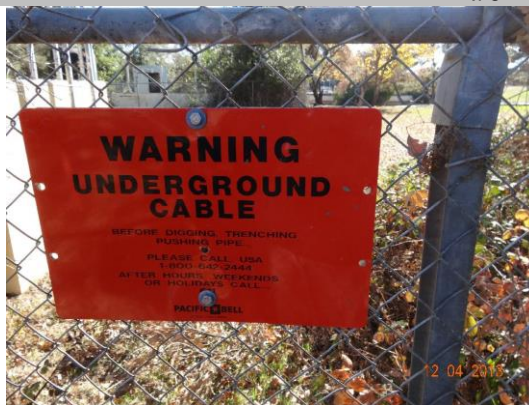
Photo 3 of 3 : UCIP_SP_2019_26299_47573.jpg

Sign for underground cable with contact information.

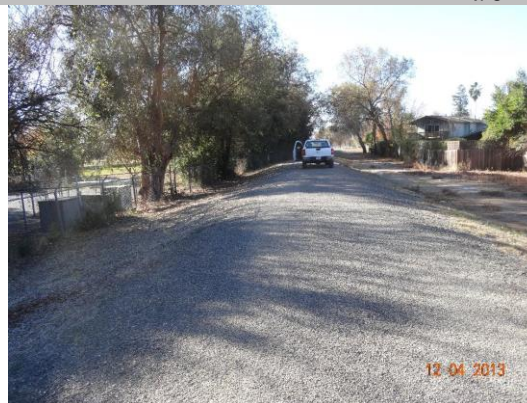
Photo 1 of 3 : UCIP_SP_2019_26296_47558.jpg

Comment Code					
Inspector Comment					
FS_ID:26296 DS_ID:24568 EP_NO: 3599B Repair Type: Non-Urgent Crossing Status: Indicator Found UCIP Comments: Need to determine status of structure-unable to determine if crossing is being used. Only indicator visible during inspection was the underground alert service markers and spray paint visible on the levee crown. FIELD_STRUCT_DESC: [River Walkway Station] 1 of 3: 12-inch concrete encased pipe through the levee, 15.3 feet below the crown. Two cutoff walls around pipe in line with each shoulder. Slide gate in concrete gate structure at landside (LS) toe-not found 2013. Sewage treatment plant on waterside (WS). Control valve in concrete box on the WS. Contact: Sacramento Regional Office 875-9400; Oscar Starks (Supervisor) 916-204-5143; Troy Shurock 916-599-2413. (one 54-inch and two 42-inch pipes authorized under Permit No. 3599B, 1964-County of Sacramento, Department of Public Works Northeast Sacramento County Sanitation District) [Additional Reference(s): DWR Levee Log, 2002] FS Date: 12/4/2013

Overview of levee crown looking downstream.

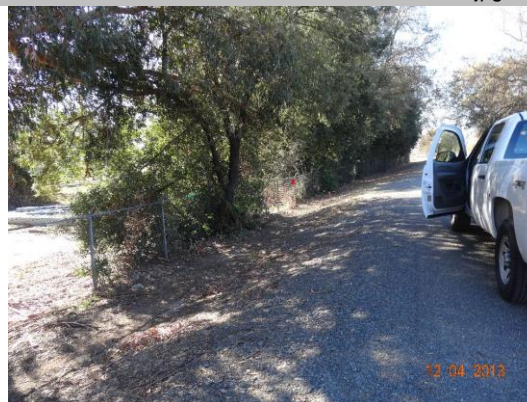
Photo 2 of 3 : UCIP_SP_2019_26296_47559.jpg

View of waterward side.

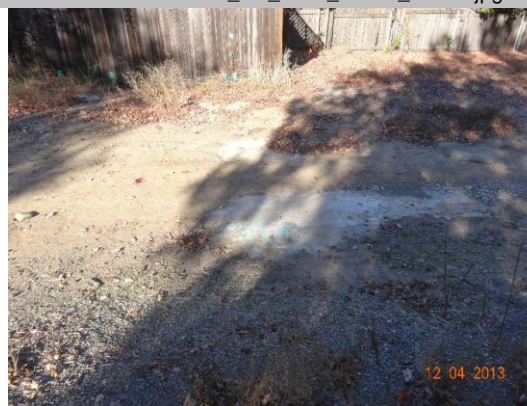
Photo 3 of 3 : UCIP_SP_2019_26296_47560.jpg

Comment Code						
Inspector Comment						
FS_ID:26296 DS_ID:24568 EP_NO: 3599B Repair Type: Non-Urgent Crossing Status: Indicator Found UCIP Comments: Need to determine status of structure-unable to determine if crossing is being used. Only indicator visible during inspection was the underground alert service markers and spray paint visible on the levee crown. FIELD_STRUCT_DESC: [River Walkway Station] 1 of 3: 12-inch concrete encased pipe through the levee, 15.3 feet below the crown. Two cutoff walls around pipe in line with each shoulder. Slide gate in concrete gate structure at landside (LS) toe-not found 2013. Sewage treatment plant on waterside (WS). Control valve in concrete box on the WS. Contact: Sacramento Regional Office 875-9400; Oscar Starks (Supervisor) 916-204-5143; Troy Shurock 916-599-2413. (one 54-inch and two 42-inch pipes authorized under Permit No. 3599B, 1964-County of Sacramento, Department of Public Works Northeast Sacramento County Sanitation District) [Additional Reference(s): DWR Levee Log, 2002] FS Date: 12/4/2013

View of landward side.

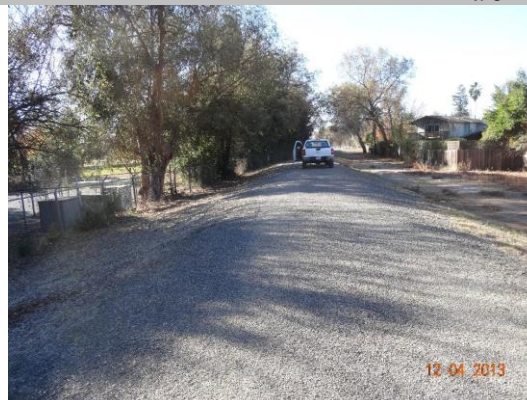
Photo 1 of 3 : UCIP_SP_2019_26298_47569.jpg

Comment Code						
Inspector Comment						
FS_ID:26298 DS_ID:24567 EP_NO: 3599A Repair Type: Non-Urgent Crossing Status: Found UCIP Comments: Need to determine status of structure. Need to coordinate with owner to determine maintenance records to confirm integrity. FIELD_STRUCT_DESC: [River Walkway Station] 2 of 3: 36-inch concrete encased pipe through the levee, 6.9 feet below the crown. Two cutoff walls around pipe in line with each shoulder. Slide gate in concrete gate structure at landside (LS) toe. Sewage treatment plant on waterside (WS). Control valve in concrete box on the WS. Contact: Sacramento Regional Office 875-9400; Oscar Starks (Supervisor) 916-204-5143; Troy Shurock 916-599-2413. (one 54-inch and two 42-inch pipes authorized under Permit No. 3599B, 1964-County of Sacramento, Department of Public Works Northeast Sacramento County Sanitation District) [Additional Reference(s): DWR Levee Log, 2002] FS Date: 12/4/2013

Overview of levee crown.

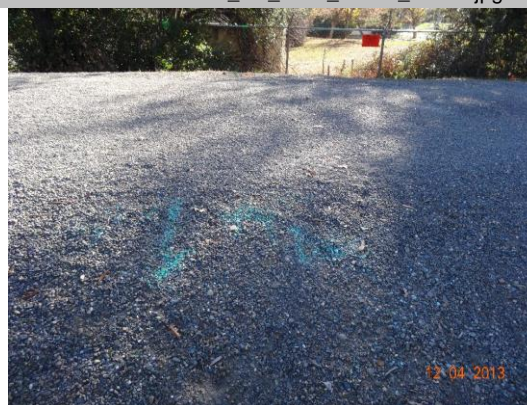
Photo 2 of 3 : UCIP_SP_2019_26298_47571.jpg

USA markers indicate alignment through levee crown.

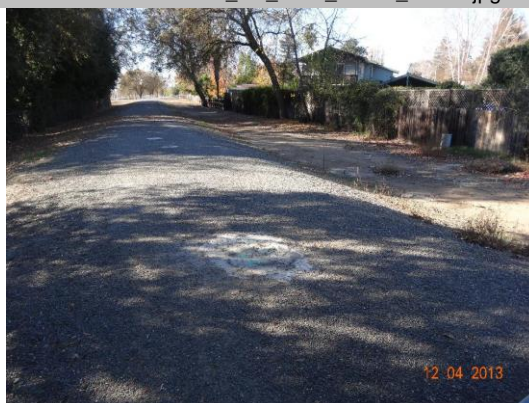
Photo 3 of 3 : UCIP_SP_2019_26298_47568.jpg

Comment Code						
Inspector Comment						
FS_ID:26298 DS_ID:24567 EP_NO: 3599A Repair Type: Non-Urgent Crossing Status: Found UCIP Comments: Need to determine status of structure. Need to coordinate with owner to determine maintenance records to confirm integrity. FIELD_STRUCT_DESC: [River Walkway Station] 2 of 3: 36-inch concrete encased pipe through the levee, 6.9 feet below the crown. Two cutoff walls around pipe in line with each shoulder. Slide gate in concrete gate structure at landside (LS) toe. Sewage treatment plant on waterside (WS). Control valve in concrete box on the WS. Contact: Sacramento Regional Office 875-9400; Oscar Starks (Supervisor) 916-204-5143; Troy Shurock 916-599-2413. (one 54-inch and two 42-inch pipes authorized under Permit No. 3599B, 1964-County of Sacramento, Department of Public Works Northeast Sacramento County Sanitation District) [Additional Reference(s): DWR Levee Log, 2002] FS Date: 12/4/2013

Overview of levee crown with grout holes visible at the crown along pipe alignment.

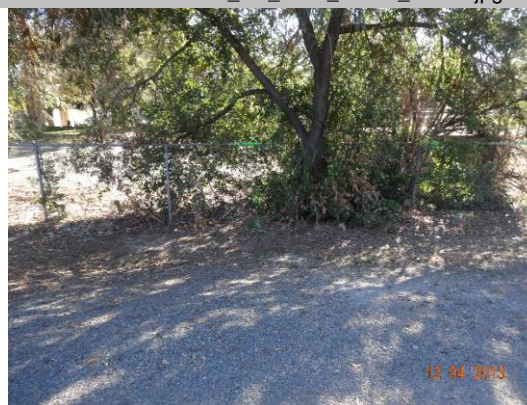
Photo 2 of 3 : UCIP_SP_2019_26426_47980.jpg

Comment Code						
Inspector Comment						
FS_ID:26426 DS_ID:24098 EP_NO: 3599 Repair Type: Non-Urgent Crossing Status: Indicator Found UCIP Comments: Need to determine status of structure--unable to determine if crossing is still being used. Underground service alert (USA) flag indicates 60 inch pipe through levee. Need to clarify. FIELD_STRUCT_DESC: [River Walkway Station] 3 of 3: 54-inch concrete encased pipe through the levee, 8.5 feet below the crown. Two cutoff walls around pipe in line with each shoulder. Slide gate in concrete gate structure at landside (LS) toe. Sewage treatment plant on waterside (WS). Control valve in concrete box on the WS. Contact: Sacramento Regional Office 875-9400; Oscar Starks (Supervisor) 916-204-5143; Troy Shurock 916-599-2413. (one 54-inch and two 42-inch pipes authorized under Permit No. 3599B, 1964-County of Sacramento, Department of Public Works Northeast Sacramento County Sanitation District) [Additional Reference(s): DWR Levee Log, 2002] FS Date: 12/4/2013

View of Underground Service Alert (USA) markers and flags confirming buried sewer lines.

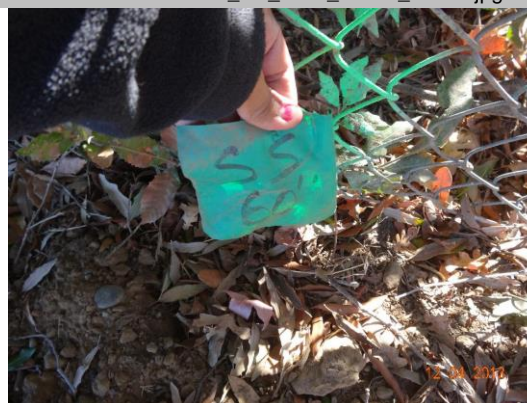
Photo 3 of 3 : UCIP_SP_2019_26426_47984.jpg

Comment Code						
Inspector Comment						
FS_ID:26426 DS_ID:24098 EP_NO: 3599 Repair Type: Non-Urgent Crossing Status: Indicator Found UCIP Comments: Need to determine status of structure--unable to determine if crossing is still being used. Underground service alert (USA) flag indicates 60 inch pipe through levee. Need to clarify. FIELD_STRUCT_DESC: [River Walkway Station] 3 of 3: 54-inch concrete encased pipe through the levee, 8.5 feet below the crown. Two cutoff walls around pipe in line with each shoulder. Slide gate in concrete gate structure at landside (LS) toe. Sewage treatment plant on waterside (WS). Control valve in concrete box on the WS. Contact: Sacramento Regional Office 875-9400; Oscar Starks (Supervisor) 916-204-5143; Troy Shurock 916-599-2413. (one 54-inch and two 42-inch pipes authorized under Permit No. 3599B, 1964-County of Sacramento, Department of Public Works Northeast Sacramento County Sanitation District) [Additional Reference(s): DWR Levee Log, 2002] FS Date: 12/4/2013

USA marker indicates 60 inch line through levee.

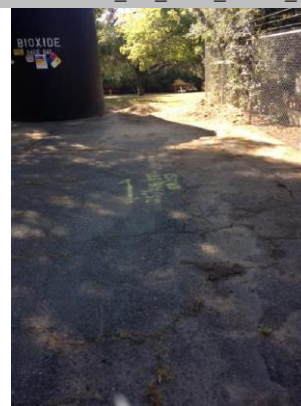
Photo 1 of 3 : UCIP_SP_2019_50053_75902.jpg

LM Start	1.29	Rating **	M	Issue No.	62
LM End	1.29	Issue Type +	En	Location *	
Category	Supplemental			GPS Latitude/Longitude	
				Start	End
Item	DWR UCIP Field Study			38.583728 °	38.583728 °
				-121.340178 °	-121.340178 °
DWR ID	25449				
Comment Code					
Inspector Comment					
FS_ID:50053 DS_ID:25449 EP_NO: N/A Repair Type: Non-Urgent Crossing Status: Indicator Found UCIP Comments: FIELD_STRUCT_DESC: 3-inch plastic vinyl (PVC) conduit chlorine line sleeved through steel pipe through the right bank of the levee, 2 feet below crown. Contact: Sacramento Regional Office 875-9400; Oscar Starks (Supervisor) 916-204-5143; Troy Shurock 916-599-2413. (3-inch line authorized under Permit No. 4535-1964, Northeast Sacramento County Sanitation District) FS Date: 4/1/2016

WS View - underground service alert (USA) markings indicating pipe alignment.

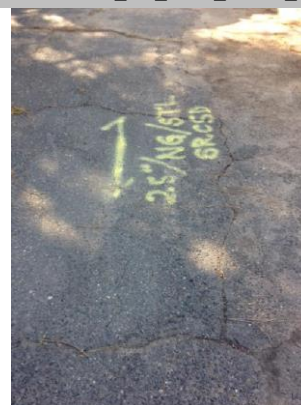
Photo 2 of 3 : UCIP_SP_2019_50053_75903.jpg

USA markings indicate 2.5-inch steel line.

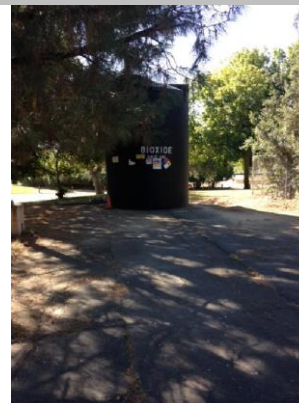
Photo 3 of 3 : UCIP_SP_2019_50053_75904.jpg

LM Start	1.29	Rating **	M	Issue No.	62 (cont)	
LM End	1.29	Issue Type +	En	Location *		
Category	Supplemental			GPS Latitude/Longitude		
				Start		End
Item	DWR UCIP Field Study			38.583728 °	38.583728 °	
				-121.340178 °	-121.340178 °	
DWR ID	25449					
Comment Code						
Inspector Comment						
FS_ID:50053 DS_ID:25449 EP_NO: N/A Repair Type: Non-Urgent Crossing Status: Indicator Found UCIP Comments: FIELD_STRUCT_DESC: 3-inch plastic vinyl (PVC) conduit chlorine line sleeved through steel pipe through the right bank of the levee, 2 feet below crown. Contact: Sacramento Regional Office 875-9400; Oscar Starks (Supervisor) 916-204-5143; Troy Shurock 916-599-2413. (3-inch line authorized under Permit No. 4535-1964, Northeast Sacramento County Sanitation District) FS Date: 4/1/2016

Storage tank located on WS.

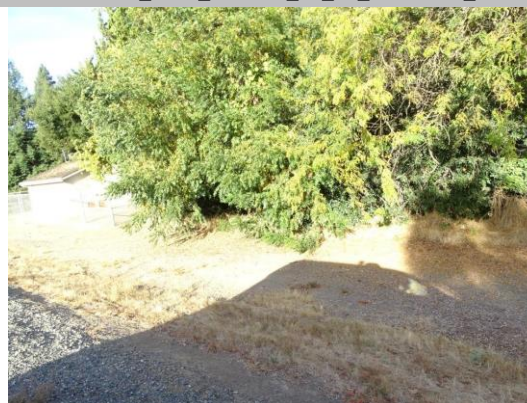
Photo 1 of 1 : SP_2019_NA0001_61_25_20190307_00005.jpg

LM Start	1.51	Rating **	M	Issue No.	25	
LM End	1.51	Issue Type +	Ma	Location *	LS	
Category	Earthen Levee			GPS Latitude/Longitude		
				Start		End
Item	Encroachments			38.581745 °		38.581745 °
				-121.343357 °		-121.343357 °
DWR ID	DWR_NA0001_10_f_2018_25					
Comment Code						
TR : Tree or limb						
Inspector Comment						
Vegetation partially obstructs access.

View of vegetation at landside toe. Fall 2018

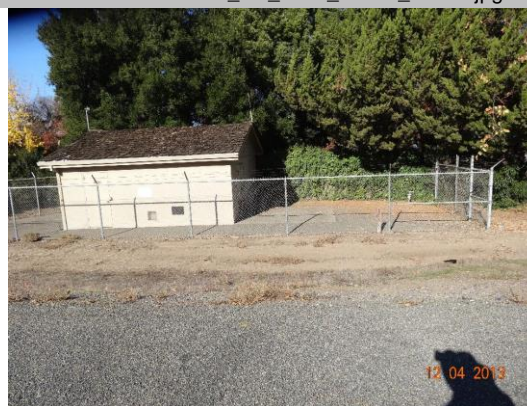
Photo 1 of 3 : UCIP_SP_2019_41548_54880.jpg

LM Start	1.53	Rating **	M	Issue No.	63	
LM End	1.53	Issue Type +	En	Location *		
Category	Supplemental			GPS Latitude/Longitude		
				Start	End	
Item	DWR UCIP Field Study			38.581594 °	38.581594 °	
				-121.343622 °	-121.343622 °	
DWR ID	24419					
Comment Code						
Inspector Comment						
FS_ID:41548						
DS_ID:24419						
EP_NO: N/A						
Repair Type: Non-Urgent						
Crossing Status: Found						
UCIP Comments: Need to find out the status of crossing--unable to determine if crossing is being used.						
FIELD_STRUCT_DESC: 24-inch pipe of unknown purpose or material through the levee, 7 feet below the crown. Concrete inspection box at waterside (WS) toe.						
FS Date: 12/4/2013

Structure located on landward side.

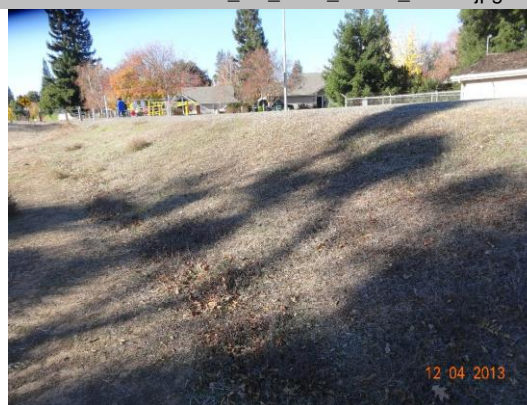
Photo 2 of 3 : UCIP_SP_2019_41548_54881.jpg

View of waterward side.

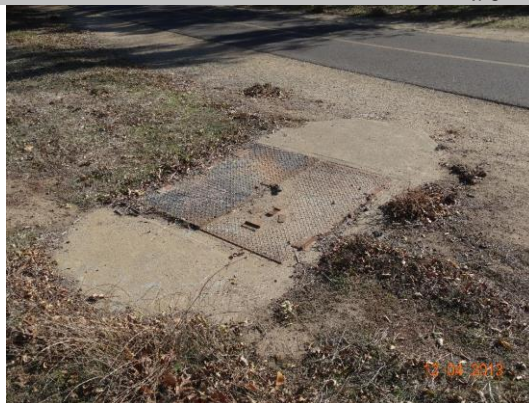
Photo 3 of 3 : UCIP_SP_2019_41548_54883.jpg

LM Start	1.53	Rating **	M	Issue No.	63 (cont)	
LM End	1.53	Issue Type +	En	Location *		
Category	Supplemental			GPS Latitude/Longitude		
				Start	End	
Item	DWR UCIP Field Study			38.581594 °	38.581594 °	
				-121.343622 °	-121.343622 °	
DWR ID	24419					
Comment Code						
Inspector Comment						
FS_ID:41548						
DS_ID:24419						
EP_NO: N/A						
Repair Type: Non-Urgent						
Crossing Status: Found						
UCIP Comments: Need to find out the status of crossing--unable to determine if crossing is being used.						
FIELD_STRUCT_DESC: 24-inch pipe of unknown purpose or material through the levee, 7 feet below the crown. Concrete inspection box at waterside (WS) toe.						
FS Date: 12/4/2013

Concrete box located on waterward side near paved trail.

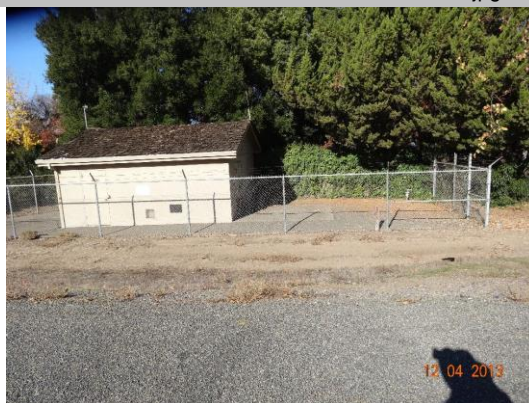
Photo 1 of 3 : UCIP_SP_2019_41546_57290.jpg

LM Start	1.53	Rating **	M	Issue No.	64	
LM End	1.53	Issue Type +	En	Location *		
Category	Supplemental			GPS Latitude/Longitude		
				Start	End	
Item	DWR UCIP Field Study			38.581588 °	38.581588 °	
				-121.343631 °	-121.343631 °	
DWR ID	24101					
Comment Code						
Inspector Comment						
FS_ID:41546						
DS_ID:24101						
EP_NO: N/A						
Repair Type: Non-Urgent						
Crossing Status: Found						
UCIP Comments: Need to determine the status of crossing--unable to determine if crossing is still active.						
FIELD_STRUCT_DESC: 8-inch pipe of unknown purpose or material through the levee at unknown depth. Concrete inspection box on the landside (LS) slope. [Additional Reference(s): DWR Levee Log, 2002]						
FS Date: 12/4/2013

Structure located on waterward side.

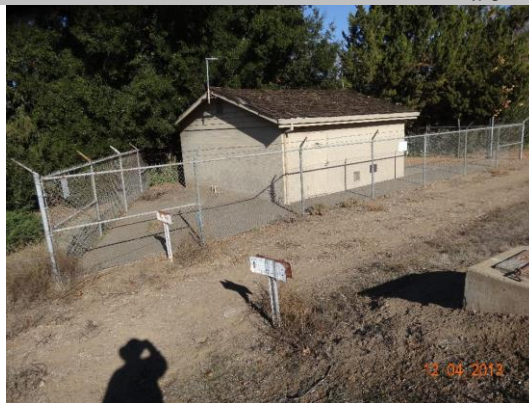
Photo 2 of 3 : UCIP_SP_2019_41546_57289.jpg

LM Start	1.53	Rating **	M	Issue No.	64 (cont)	
LM End	1.53	Issue Type +	En	Location *		
Category	Supplemental			GPS Latitude/Longitude		
				Start	End	
Item	DWR UCIP Field Study			38.581588 °	38.581588 °	
				-121.343631 °	-121.343631 °	
DWR ID	24101					
Comment Code						
Inspector Comment						
FS_ID:41546						
DS_ID:24101						
EP_NO: N/A						
Repair Type: Non-Urgent						
Crossing Status: Found						
UCIP Comments: Need to determine the status of crossing--unable to determine if crossing is still active.						
FIELD_STRUCT_DESC: 8-inch pipe of unknown purpose or material through the levee at unknown depth. Concrete inspection box on the landside (LS) slope. [Additional Reference(s): DWR Levee Log, 2002]						
FS Date: 12/4/2013

View of landward side--chlorine line adjacent to 8-inch pipe.

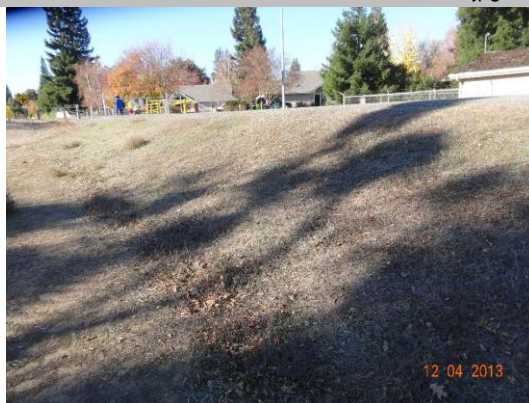
Photo 3 of 3 : UCIP_SP_2019_41546_57291.jpg

View of waterward side.

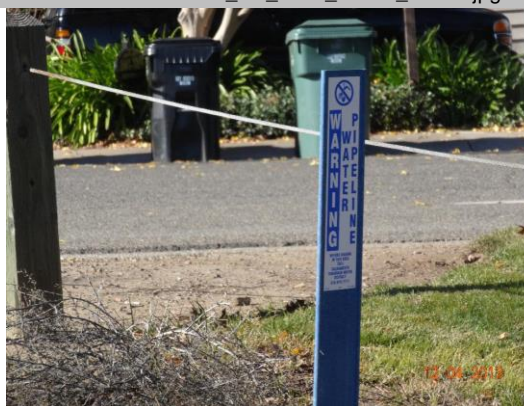
Photo 1 of 2 : UCIP_SP_2019_30575_56338.jpg

LM Start	1.61	Rating **	M	Issue No.	65	
LM End	1.61	Issue Type +	En	Location *		
Category	Supplemental			GPS Latitude/Longitude		
				Start	End	
Item	DWR UCIP Field Study			38.580991 °	38.580991 °	
				-121.344917 °	-121.344917 °	
DWR ID	24822					
Comment Code						
Inspector Comment						
FS_ID:30575						
DS_ID:24822						
EP_NO: N/A						
Repair Type: Non-Urgent						
Crossing Status: Indicator Found						
UCIP Comments: 2nd marker visible on landward side at levee mile 1.63 (38.581564 -121.343806).						
FIELD_STRUCT_DESC: Marker indicating water line located on landside (LS) toe. Unable to determine if line runs parallel to levee or if line crosses levee. Unable to find permit for work.						
FS Date: 12/4/2013

Waterline marker at levee mile 1.63.

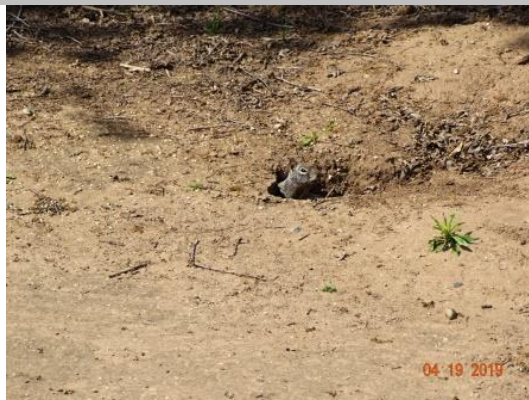
Photo 1 of 2 : SP_2019_NA0001_61_36_20190422_00048.jpg

LM Start	2.07	Rating **	M	Issue No.	36
LM End	2.07	Issue Type +	Ma	Location *	LS
Category	Earthen Levee			GPS Latitude/Longitude	
				Start	End
Item	Animal Control			38.577573 °	38.577573 °
				-121.352332 °	-121.352332 °
DWR ID	DWR_NA0001_10_s_2019_36				
Comment Code					
A1 : Exterminate rodents and backfill and compact or grout burrows.					
Inspector Comment

View of squirrel hole with activity along toe road. Spring 2019

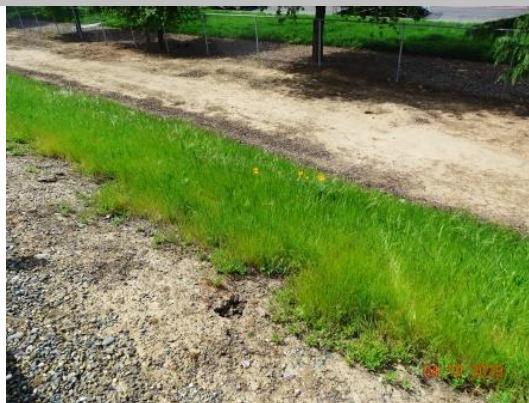
Photo 2 of 2 : SP_2019_NA0001_61_36_20190422_00050.jpg

View of animal holes on levee slope and toe road. Spring 2019

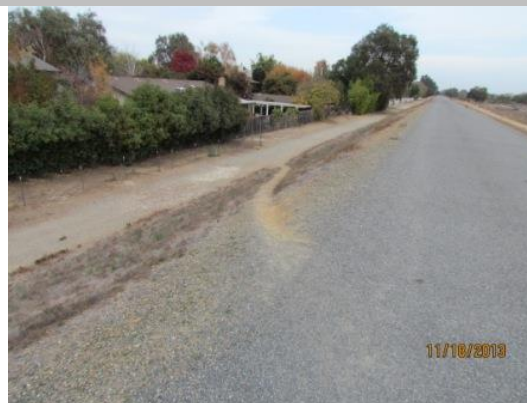
Photo 1 of 1 : SP_2019_NA0001_61_7_20190307_00002.jpg

LM Start	2.41	Rating **	A/W	Issue No.	7
LM End	2.41	Issue Type +	Ma	Location *	LS
Category	Earthen Levee			GPS Latitude/Longitude	
				Start	End
Item	Slope Stability			38.575126 °	38.575126 °
				-121.357575 °	-121.357575 °
DWR ID	DWR_NA0001_10_f_2013_7				
Comment Code					
S2 : Repair the levee slope damaged by foot traffic and prevent access where possible.					
Inspector Comment

View of the pathway on the landside levee slope.

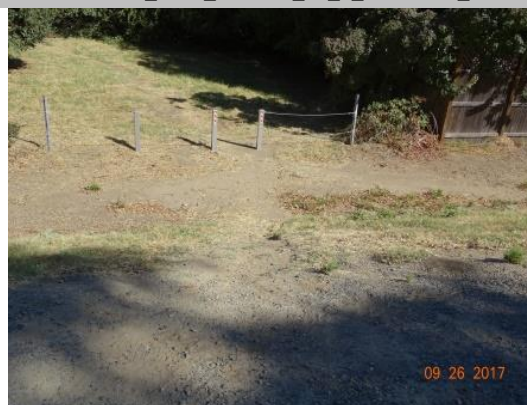
Photo 1 of 1 : SP_2019_NA0001_61_2_20190307_00001.jpg

LM Start	3.22	Rating **	A/W	Issue No.	2
LM End	3.22	Issue Type +	Ma	Location *	LS
Category	Earthen Levee			GPS Latitude/Longitude	
				Start	End
Item	Slope Stability			38.569955 °	38.569955 °
				-121.370988 °	-121.370988 °
DWR ID	DWR_NA0001_10_f_2017_2				
Comment Code					
S2 : Repair the levee slope damaged by foot traffic and prevent access where possible.					
Inspector Comment					
Monitor the footpath for possible further erosion.

View of the footpath on the levee slope. Fall 2017

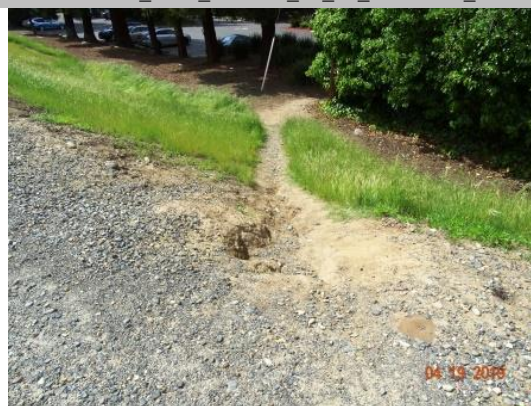
Photo 1 of 1 : SP_2019_NA0001_61_19_20190422_00051.jpg

LM Start	3.48	Rating **	M	Issue No.	19
LM End	3.48	Issue Type +	Ma	Location *	LS
Category	Earthen Levee			GPS Latitude/Longitude	
				Start	End
Item	Slope Stability			38.569494 °	38.569494 °
				-121.375684 °	-121.375684 °
DWR ID	DWR_NA0001_10_f_2018_19				
Comment Code					
S2 : Repair the levee slope damaged by foot traffic and prevent access where possible.					
Inspector Comment

View of footpath on landside slope. Spring 2019

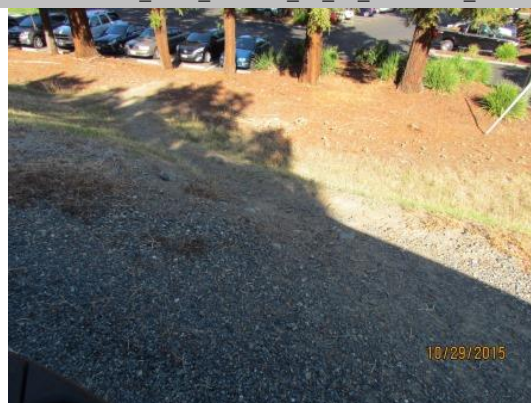
Photo 2 of 2 : SP_2019_NA0001_61_21_20190307_00004.jpg

LM Start	3.49	Rating **	M	Issue No.	21
LM End	3.49	Issue Type +	Ma	Location *	LS
Category	Earthen Levee			GPS Latitude/Longitude	
				Start	End
Item	Slope Stability			38.569484 °	38.569484 °
				-121.375841 °	-121.375841 °
DWR ID	DWR_NA0001_10_f_2015_21				
Comment Code					
S2 : Repair the levee slope damaged by foot traffic and prevent access where possible.					
Inspector Comment

View of the footpath on the landside levee slope.

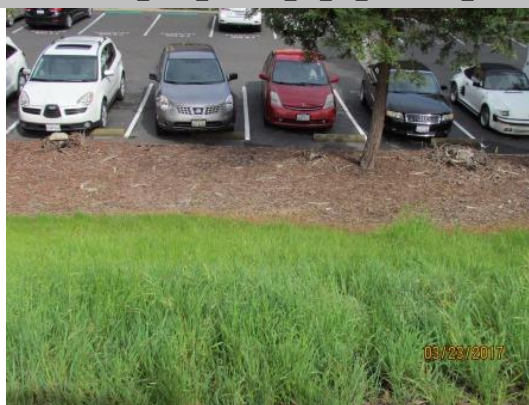
Photo 1 of 1 : SP_2019_NA0001_61_29_20190307_00009.jpg

LM Start	3.56	Rating **	N	Issue No.	29
LM End	3.56	Issue Type +	Ma	Location *	LS
Category	Earthen Levee			GPS Latitude/Longitude	
				Start	End
Item	Trim / Thin Trees			38.569242 °	38.569242 °
				-121.377169 °	-121.377169 °
DWR ID	DWR_NA0001_10_s_2017_29				
Comment Code					
T5 : Tree stumps.					
Inspector Comment					
Three tree stumps are within the levee easement.

View of the tree stumps within the levee easement.

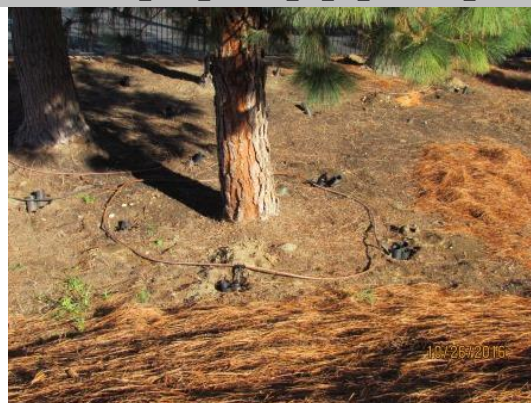
Photo 1 of 1 : SP_2019_NA0001_61_27_20190307_00007.jpg

LM Start	3.76	Rating **	M	Issue No.	27
LM End	3.76	Issue Type +	En	Location *	LS
Category	Earthen Levee			GPS Latitude/Longitude	
				Start	End
Item	Encroachments			38.568413 °	38.568413 °
				-121.380711 °	-121.380711 °
DWR ID	DWR_NA0001_10_f_2016_27				
Comment Code					
LI : Landscape Irrigation					
Inspector Comment					
Permit required for irrigation within 10-feet of levee toe.

View of the landscaping irrigation at the landside levee toe.

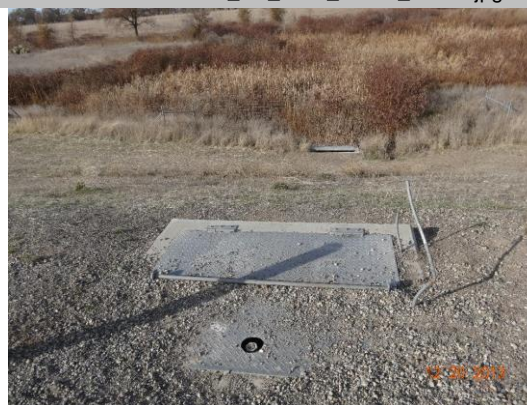
Photo 1 of 3 : UCIP_SP_2019_31310_57345.jpg

Comment Code					
Inspector Comment					
FS_ID:31310 DS_ID:24823 EP_NO: N/A Repair Type: Non-Urgent Crossing Status: Found UCIP Comments: 08/16/2017 DWR Deferred Maintenance Project (DMP), Vince Rodriguez, forwarded email received from Tim Kerr, General Manager of American River Flood Control District (ARFCD) with file "DWR Eligible Pipes Found in ARFCD" from ARFCD that shows the ownership and location of the pipes Tim Kerr investigated. Owner of this crossing is identified as the City of Sacramento, ARFCD Staff Notes indicate Claire Ave. (DWR UCIP - O. Magana) 12/20/2013 no permit found--owner? (unauthorized?) (DWR UCIP - O. Magana) FIELD_STRUCT_DESC: 24-inch pipe through the levee at unknown depth. Concrete box located on waterside (WS) shoulder. Concrete wall located on waterside (WS) and landside (LS). Siphon breaker inside concrete service box located on WS shoulder. (no permit has been identified authorizing this structure, structure is owned by the City of Sacramento) FS Date: 12/20/2013

View of waterward side.

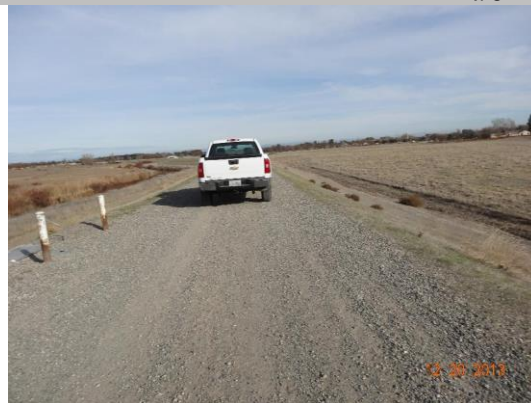
Photo 2 of 3 : UCIP_SP_2019_31310_57342.jpg

LM Start	0.08	Rating **	M	Issue No.	11 (cont)
LM End	0.08	Issue Type +	En	Location *

View of levee crown at crossing.

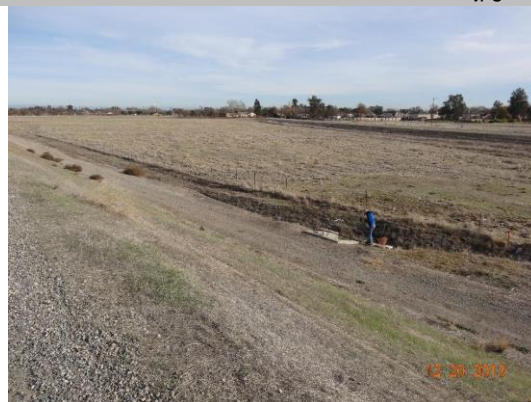
Photo 3 of 3 : UCIP_SP_2019_31310_57343.jpg

View of landward side.

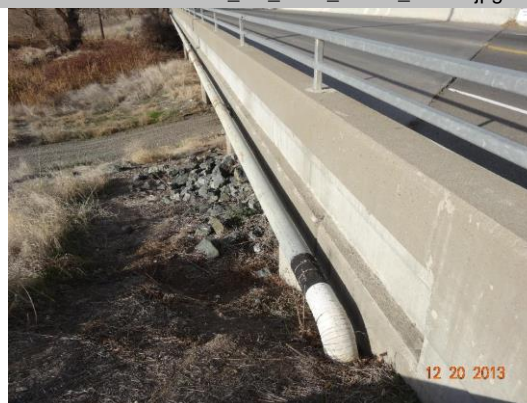
Photo 1 of 1 : UCIP_SP_2019_31311_57346.jpg

LM Start	0.48	Rating **	M	Issue No.	12
LM End	0.48	Issue Type +	En	Location *	
Category	Supplemental			GPS Latitude/Longitude	
				Start	End
Item	DWR UCIP Field Study			38.666585 °	38.666585 °
				-121.451009 °	-121.451009 °
DWR ID	24824				
Comment Code					
Inspector Comment					
FS_ID:31311					
DS_ID:24824					
EP_NO: N/A					
Repair Type: Non-Urgent					
Crossing Status: Found					
UCIP Comments: owner? permit? (unauthorized?)					
FIELD_STRUCT_DESC: 6-inch conduit through levee at unknown					
depth. Conduit extends across the channel, attached to bridge.					
FS Date: 12/20/2013

Crossing visible on waterward side.

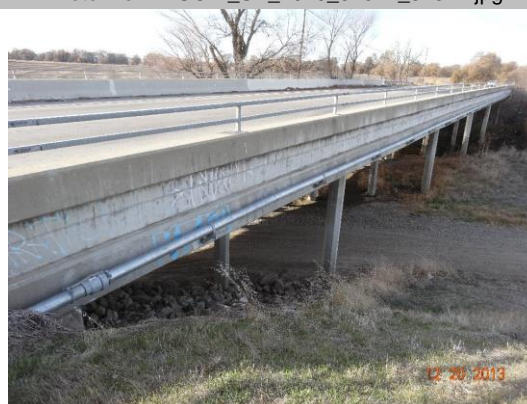
Photo 1 of 1 : UCIP_SP_2019_31312_57347.jpg

LM Start	0.49	Rating **	M	Issue No.	13	
LM End	0.49	Issue Type +	En	Location *		
Category	Supplemental			GPS Latitude/Longitude		
				Start	End	
Item	DWR UCIP Field Study			38.666745 °	38.666745 °	
				-121.450918 °	-121.450918 °	
DWR ID	24825					
Comment Code						
Inspector Comment						
FS_ID:31312						
DS_ID:24825						
EP_NO: N/A						
Repair Type: Non-Urgent						
Crossing Status: Found						
UCIP Comments: owner? permit? (unauthorized?)						
FIELD_STRUCT_DESC: 4-inch communication conduit of unknown material through levee at unknown depth. Conduit extends across the channel, attached to bridge.						
FS Date: 12/20/2013

Conduit attached to the upstream face of Rio Linda Blvd Bridge.

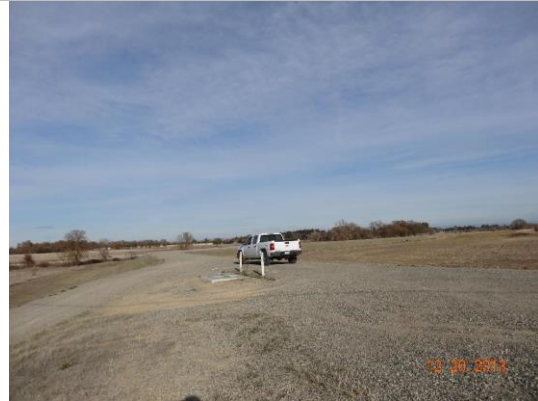
Photo 1 of 3 : UCIP_SP_2019_31313_57349.jpg

LM Start	0.52	Rating **	M	Issue No.	14 (cont)
LM End	0.52	Issue Type +	En	Location *

View of levee crown at crossing.

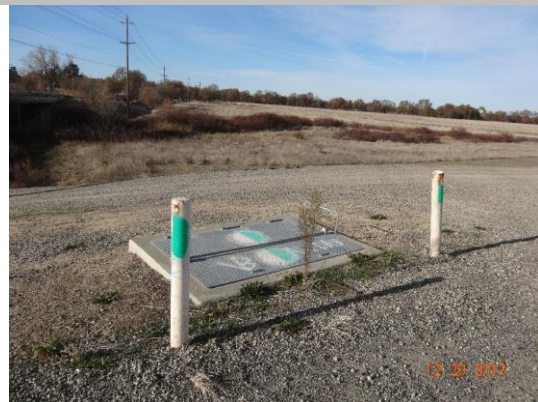
Photo 2 of 3 : UCIP_SP_2019_31313_57348.jpg

Concrete vault with protective posts located on waterward shoulder.

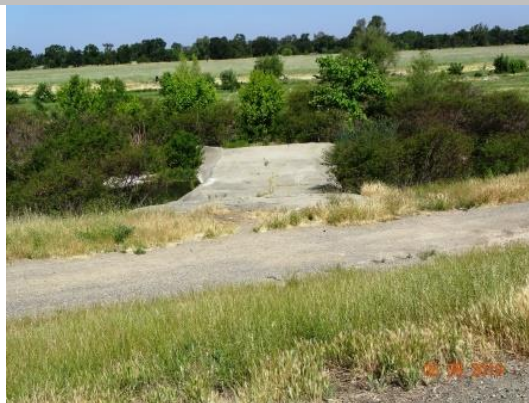
Photo 1 of 2 : SP_2019_NA0001_436_10_20190523_00010.jpg

LM Start	1.29	Rating **	M	Issue No.	10
LM End	1.29	Issue Type +	En	Location *	WS
Category	Earthen Levee			GPS Latitude/Longitude	
				Start	End
Item	Encroachments			38.665072 °	38.665072 °
				-121.452520 °	-121.452520 °
DWR ID	DWR_NA0001_11_s_2019_10				
Comment Code					
RA : Ramp					
Inspector Comment					
A concrete ramp over the creek does not appear to be authorized. Culverts are built into it.

View looking north at concrete ramp over creek. Spring 2019

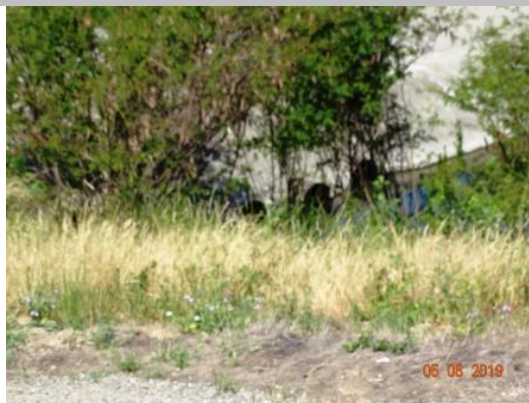
Photo 2 of 2 : SP_2019_NA0001_436_10_20190523_00011.jpg

LM Start	1.29	Rating **	M	Issue No.	10 (cont)
LM End	1.29	Issue Type +	En	Location *	WS

View looking north at culverts built into ramp. Spring 2019

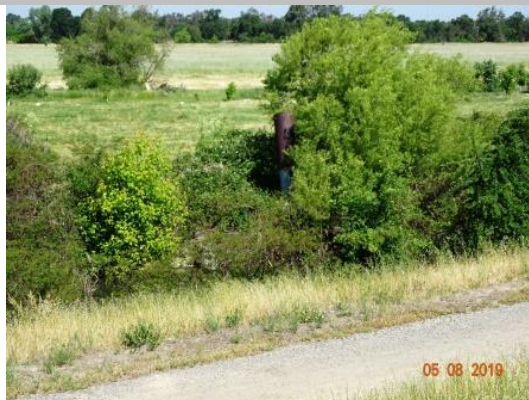
Photo 1 of 1 : SP_2019_NA0001_436_8_20190523_00012.jpg

LM Start	1.29	Rating **	M	Issue No.	8
LM End	1.29	Issue Type +	En	Location *	WS
Category	Earthen Levee			GPS Latitude/Longitude	
				Start	End
Item	Encroachments			38.665237 °	38.665237 °
				-121.452417 °	-121.452417 °
DWR ID	DWR_NA0001_11_s_2019_8				
Comment Code					
PI : Pipe					
Inspector Comment					
A metal standpipe does not appear to be authorized within the creek.

View looking north at a metal standpipe within the creek. Spring 2019

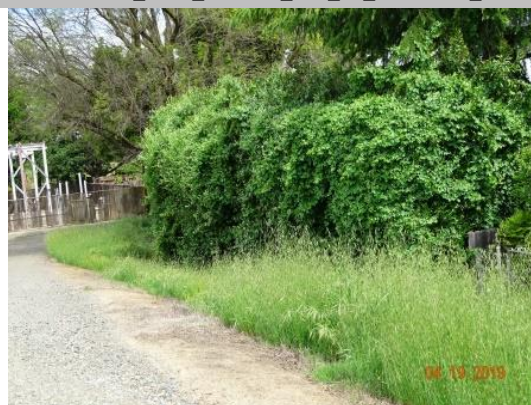
Photo 1 of 1 : SP_2019_NA0001_438_17_20190422_00017.jpg

LM Start	0.02	Rating **	M	Issue No.	17
LM End	0.02	Issue Type +	En	Location *	LS
Category	Earthen Levee			GPS Latitude/Longitude	
				Start	End
Item	Vegetation			38.570323 °	38.570323 °
				-121.353337 °	-121.353337 °
DWR ID	DWR_NA0001_12_s_2019_17				
Comment Code					
V6 : Landscaping					
Inspector Comment					
Tall ivy is growing within levee easement.

View of landscaping that grows into levee easement. Spring 2019

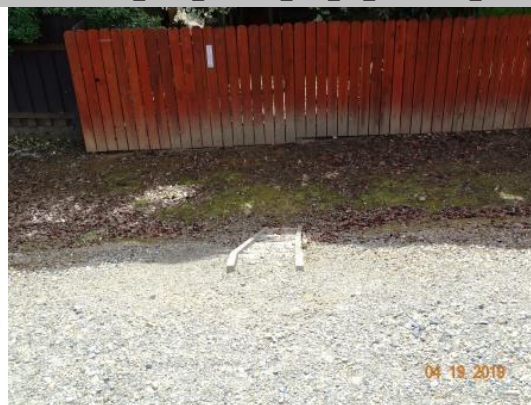
Photo 1 of 1 : SP_2019_NA0001_438_15_20190422_00016.jpg

LM Start	0.28	Rating **	M	Issue No.	15
LM End	0.28	Issue Type +	En	Location *	LS
Category	Earthen Levee			GPS Latitude/Longitude	
				Start	End
Item	Encroachments			38.572765 °	38.572765 °
				-121.350565 °	-121.350565 °
DWR ID	DWR_NA0001_12_s_2019_15				
Comment Code					
ST : Stairway					
Inspector Comment					
Landowner installed wooden stairway on levee slope.

View looking south at wooden stairs built into levee slope. Spring 2019

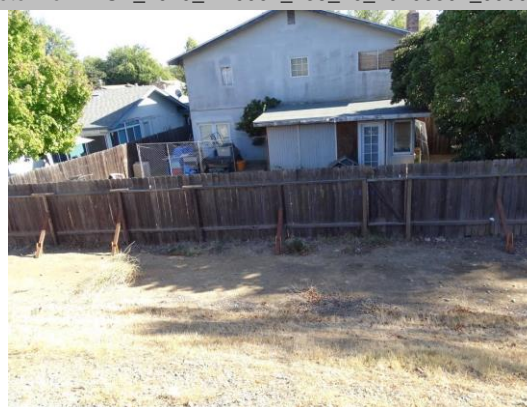
Photo 1 of 1 : SP_2019_NA0001_438_10_20190307_00006.jpg

LM Start	0.47	Rating **	M	Issue No.	10
LM End	0.47	Issue Type +	En	Location *	LS
Category	Earthen Levee			GPS Latitude/Longitude	
				Start	End
Item	Encroachments			38.574625 °	38.574625 °
				-121.347787 °	-121.347787 °
DWR ID	DWR_NA0001_12_f_2018_10				
Comment Code					
FE : Fence					
Inspector Comment					
Fence bracing partially blocks access.

View of fence bracing that partially blocks access. Fall 2018

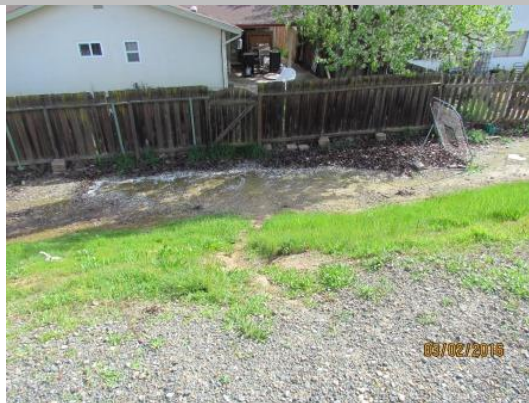
Photo 1 of 1 : SP_2019_NA0001_438_4_20190307_00003.jpg

LM Start	0.56	Rating **	A/W	Issue No.	4
LM End	0.56	Issue Type +	Ma	Location *	LS
Category	Earthen Levee			GPS Latitude/Longitude	
				Start	End
Item	Slope Stability			38.575370 °	38.575370 °
				-121.346583 °	-121.346583 °
DWR ID	DWR_NA0001_12_f_2015_4				
Comment Code					
S2 : Repair the levee slope damaged by foot traffic and prevent access where possible.					
Inspector Comment

View of the footpath on the landside levee slope.

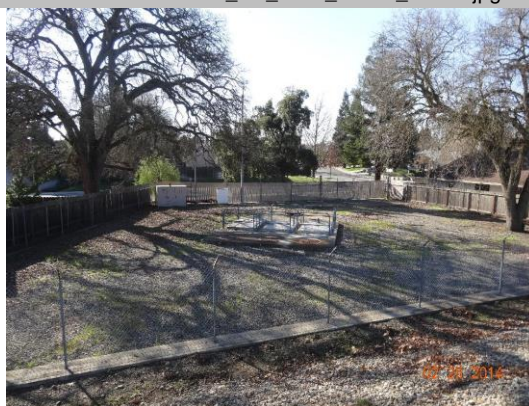
Photo 1 of 3 : UCIP_SP_2019_46995_56234.jpg

Comment Code					
Inspector Comment					
FS_ID:46995					
DS_ID:24830					
EP_NO: N/A					
Repair Type: Non-Urgent					
Crossing Status: Indicator Found					
UCIP Comments: Unable to confirm pipe size--need to contact owner to obtain additional information on crossing.					
FIELD_STRUCT_DESC: [SRCSD Facility N16 NE Siphon Outlet] 1 of 3: 48-inch reinforced concrete (RC) drainage pipe through the levee, 11 feet below crown. Pipe crosses levee at an angle. Sacramento Regional County Sanitation District (SRCSD) Facility N16 NE Siphon Outlet located on landside (LS). Facility is fenced off. Inside facility are 3 concrete boxes with 3 manholes. (three 48-inch pipes authorized under Permit No. 12144, 1978-SRCSD; cathodic protection for 48-inch pipe authorized under 12144-A, 1983-SRCSD)					
FS Date: 2/25/2014

Concrete vault located on landward side.

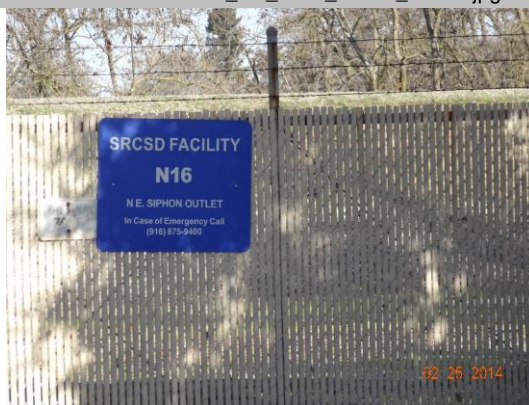
Photo 2 of 3 : UCIP_SP_2019_46995_56235.jpg

SRCSD Facility N16, NE Siphon Outlet, sign visible from Mira Del Rio Drive.

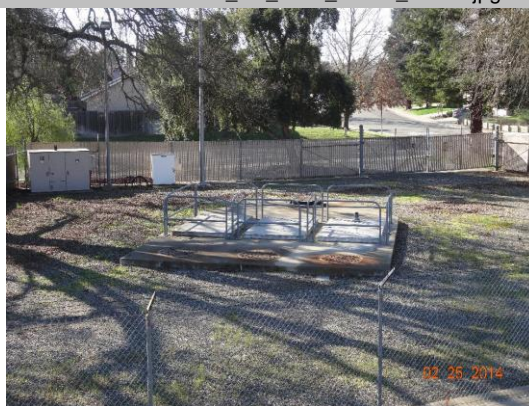
Photo 3 of 3 : UCIP_SP_2019_46995_56233.jpg

Comment Code						
Inspector Comment						
FS_ID:46995						
DS_ID:24830						
EP_NO: N/A						
Repair Type: Non-Urgent						
Crossing Status: Indicator Found						
UCIP Comments: Unable to confirm pipe size--need to contact owner to obtain additional information on crossing.						
FIELD_STRUCT_DESC: [SRCSD Facility N16 NE Siphon Outlet] 1 of 3: 48-inch reinforced concrete (RC) drainage pipe through the levee, 11 feet below crown. Pipe crosses levee at an angle. Sacramento Regional County Sanitation District (SRCSD) Facility N16 NE Siphon Outlet located on landside (LS). Facility is fenced off. Inside facility are 3 concrete boxes with 3 manholes. (three 48-inch pipes authorized under Permit No. 12144, 1978-SRCSD; cathodic protection for 48-inch pipe authorized under 12144-A, 1983-SRCSD)						
FS Date: 2/25/2014

Manholes located on landward side.

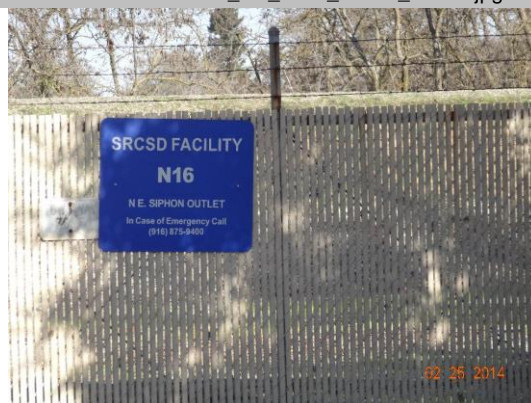
Photo 1 of 3 : UCIP_SP_2019_30540_56232.jpg

Comment Code					
Inspector Comment					
FS_ID:30540					
DS_ID:24829					
EP_NO: N/A					
Repair Type: Non-Urgent					
Crossing Status: Indicator Found					
UCIP Comments: Unable to confirm pipe size--need to contact owner to obtain additional information on crossing.					
FIELD_STRUCT_DESC: [SRCSD Facility N16 NE Siphon Outlet] 2 of 3: 48-inch reinforced concrete (RC) drainage pipe through the levee, 11 feet below crown. Pipe crosses levee at an angle. Sacramento Regional County Sanitation District (SRCSD) Facility N16 NE Siphon Outlet located on landside (LS). Facility is fenced off. Inside facility are 3 concrete boxes with 3 manholes. (three 48-inch pipes authorized under Permit No. 12144, 1978-SRCSD; cathodic protection for 48-inch pipe authorized under 12144-A, 1983-SRCSD)					
FS Date: 2/25/2014

SRCSD Facility N16, NE Siphon Outlet, sign visible from Mira Del Rio Drive.

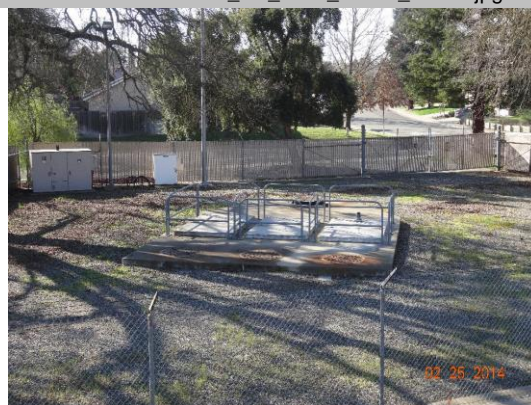
Photo 2 of 3 : UCIP_SP_2019_30540_56230.jpg

Manholes visible on landward side.

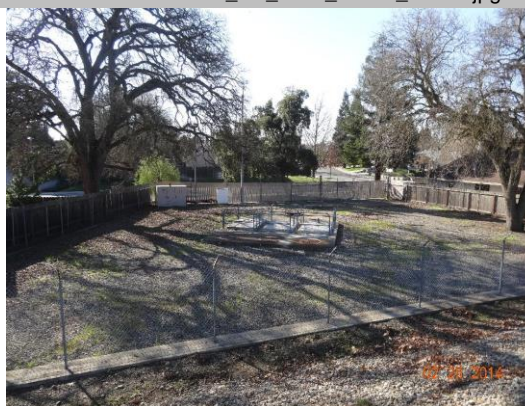
Photo 3 of 3 : UCIP_SP_2019_30540_56231.jpg

Comment Code					
Inspector Comment					
FS_ID:30540 DS_ID:24829 EP_NO: N/A Repair Type: Non-Urgent Crossing Status: Indicator Found UCIP Comments: Unable to confirm pipe size--need to contact owner to obtain additional information on crossing. FIELD_STRUCT_DESC: [SRCSD Facility N16 NE Siphon Outlet] 2 of 3: 48-inch reinforced concrete (RC) drainage pipe through the levee, 11 feet below crown. Pipe crosses levee at an angle. Sacramento Regional County Sanitation District (SRCSD) Facility N16 NE Siphon Outlet located on landside (LS). Facility is fenced off. Inside facility are 3 concrete boxes with 3 manholes. (three 48-inch pipes authorized under Permit No. 12144, 1978-SRCSD; cathodic protection for 48-inch pipe authorized under 12144-A, 1983-SRCSD) FS Date: 2/25/2014

Concrete vault located on landward side.

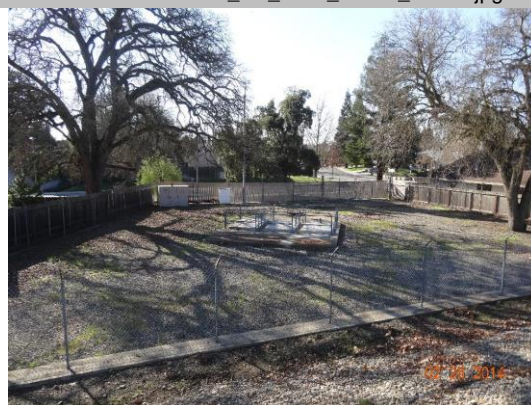
Photo 2 of 3 : UCIP_SP_2019_46994_56228.jpg

Comment Code					
Inspector Comment					
FS_ID:46994 DS_ID:24828 EP_NO: N/A Repair Type: Non-Urgent Crossing Status: Indicator Found UCIP Comments: Unable to confirm pipe size--need to contact owner to obtain additional information on crossing. FIELD_STRUCT_DESC: [SRCSD Facility N16 NE Siphon Outlet] 3 of 3: 48-inch reinforced concrete (RC) drainpipe through the levee at 11.0 feet below crown. Pipe crosses levee at an angle. Sacramento Regional County Sanitation District (SRCSD) Facility N16 NE Siphon Outlet located on landside (LS). Facility is fenced off. Inside facility are 3 concrete boxes with 3 manholes. (three 48-inch pipes authorized under Permit No. 12144, 1978-SRCSD; cathodic protection for 48-inch pipe authorized under 12144-A, 1983-SRCSD) FS Date: 2/25/2014

Concrete vault for 3 crossings located on landward side.

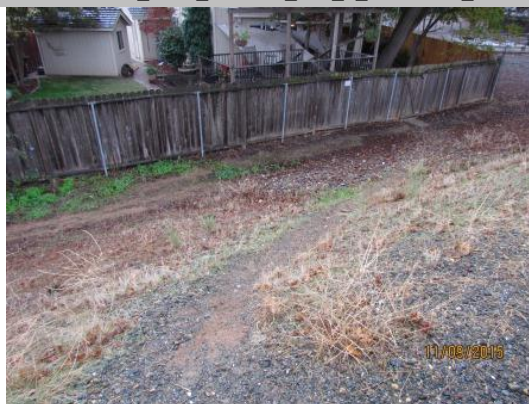
Photo 1 of 1 : SP_2019_NA0001_438_3_20190307_00002.jpg

LM Start	0.73	Rating **	A/W	Issue No.	3
LM End	0.73	Issue Type +	Ma	Location *	LS
Category	Earthen Levee			GPS Latitude/Longitude	
				Start	End
Item	Slope Stability			38.576663 °	38.576663 °
				-121.343805 °	-121.343805 °
DWR ID	DWR_NA0001_12_f_2015_3				
Comment Code					
S2 : Repair the levee slope damaged by foot traffic and prevent access where possible.					
Inspector Comment

View of the footpath on the landside levee slope.
